## LOAD TEST ON THE FIRE GUTTED NASACO BUILDING IN DAR ES SALAAM

J.K Makunza\*, S.R Mpinzire\*\* and I.A Rubaratuka\*\*

*This paper presents the load test performed to a fire-gutted multi-storey concrete structure, the results of which have shown that the strength of the structure is still adequate and needs only strengthening and repair.*

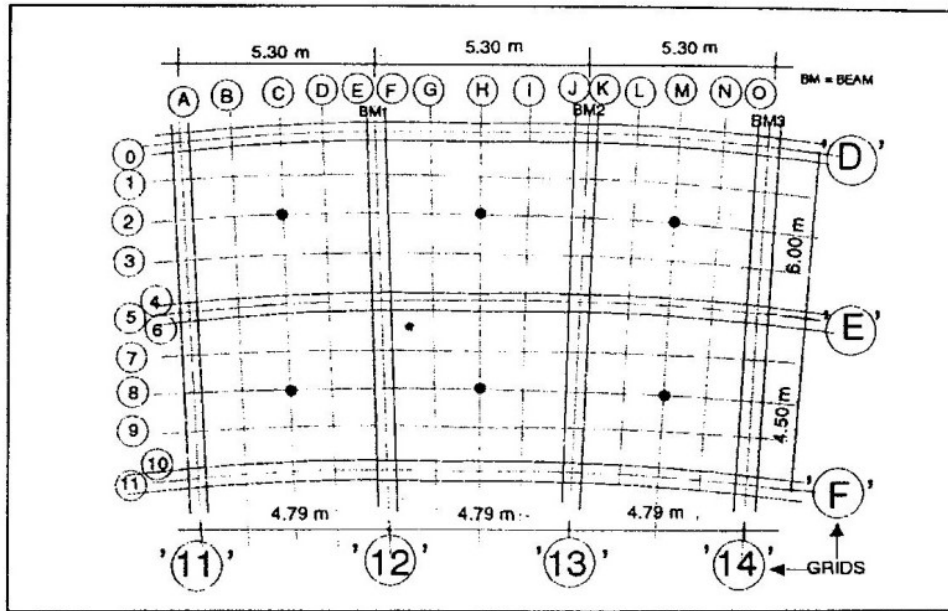
**Fig. 3 Area for Load Test and the Measured Points**

The test area was selected to be the first floor on the South-West of the Building. The chosen area and its respective points from which the spot levels were taken was between grids D, E, and F in longitudinal direction and grids 11 - 14 across the building. This area is shown in Figure 3. Out of the six slab panels which were selected for the test, two had their plaster fallen down due to the fire effect. The levelling instrument used was an automatic level Ni3 with a parallel-plate micrometer having an accuracy of  $\pm 0.0001\text{m}$ . The reading error can be estimated at  $\pm 0.0002\text{m}$ . A total number of 190 points were located and their levels taken. The surveying results can be seen in reference [4].

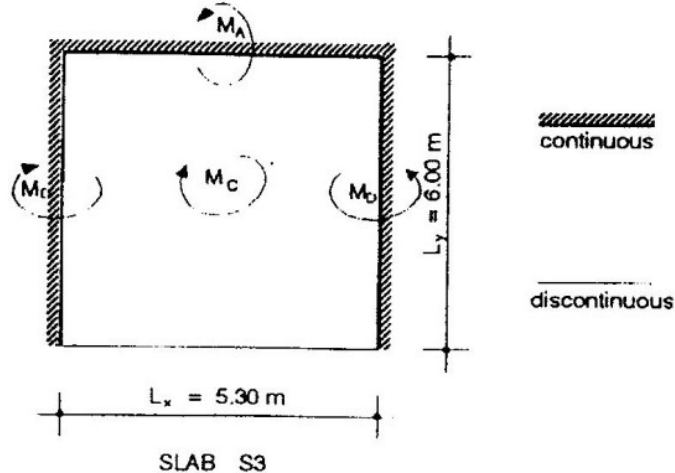
Fig. 4 Floor Slab Moments

Slab S3 shown in figure 4 was been selected because of its location in which reasonable elastic deflection can be obtained due to its end conditions. The elastic deflection for slab or beam under loading conditions is given by the equation:

The subscriptions to the moments ( $M$ ) are based on the points of consideration given in Figure 4. The assumed design load of the slab was  $16.26 \text{ kN/m}^2$ . From BS 8110: 1985 Part 1, the bending moment coefficients for a rectangular slab panel, supported on four sides with provision for torsion at corners with **one short edge discontinuous** and  $l_y/l_x = 1.13$ , are as follows:  $\beta_{syA} = -0.037$ ,  $\beta_{syC} = +0.028$ ,  $\beta_{sxD} = -0.045$  and  $\beta_{sxC} = +0.037$ . With  $L = 5.300 \text{ m}$ , the following moments were obtained; thus,  $M_A = -16.90 \text{ kN.m}$ ,  $M_{cy} = +12.79 \text{ kN.m}$ ,  $M_{cx} = +16.90 \text{ kN.m}$  and  $M_D = -20.55 \text{ kN.m}$ . Therefore upon substitution into equation (1) above, the elastic deflection is  $5.54 \text{ mm}$ .

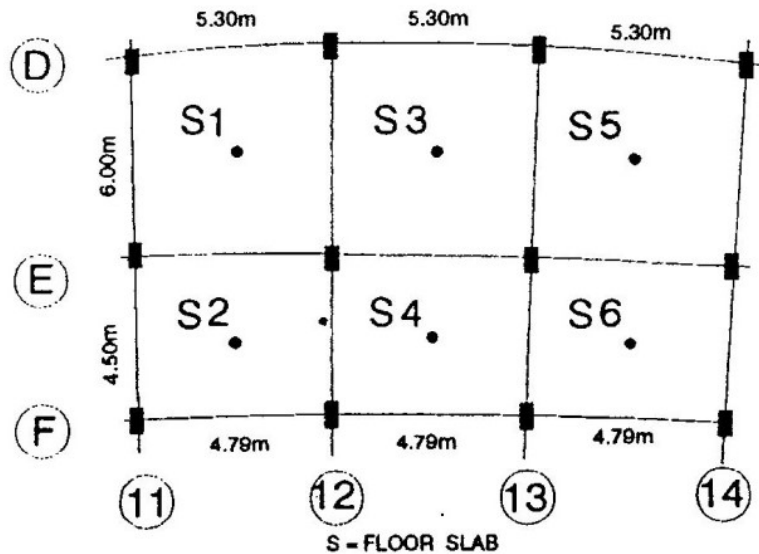
Fig. 5 Selected Central Points

Figure 5 shows the points which were significant for the assessment of deflection of the slab. Spot levels of the points of each slab panel and the respective beams were taken three times: before loading, after 24 hours under-load and after 24 hours of off-load. All levels are based on an assumed reduced level of  $20.0000 \text{ m}$  above mean sea level. The Temporary Bench Mark was a steel pipe stem for stairs opening to the

Panel	Point	Deflection in mm				Remarks
		Before loading	24 hrs under-load	24 hrs after off-load	Recovery %age	
S1	C2	0.00	1.10	0.40	64%	All deflections are smaller than the anticipated elastic ones.
S2	C8	0.00	1.30	0.70	46%	
S3	M2	0.00	1.10	0.20	82%	
S4	H8	0.00	1.50	1.30	13%	
S5	M2	0.00	1.80	0.90	50%	
S6	M9	0.00	1.20	0.50	58%

result which is higher than the calculated elastic deflection of 5.54 mm. The recovery percentage is not significant since the deflection is very small. It is difficult to assume that the temperature reached more than 300°C because of the type of the fire flammable materials which couldn't be still existing at such a temperature. Therefore, the main problem was expansion of the steel reinforcement causing spalling and falling down of cement plaster and concrete cover at some points.

The obtained results show that the structure is still strong because even the expected elastic deflection was not reached. Therefore, it is recommended that

- The structure needs repair and strengthening
- The method of strengthening should include pressure pumping of the concrete, crack injection and crack sealing.
- The methods deemed in the report of the previous consultant report have to be implemented [2].
- Due to the nature of the work to be done in restoring back the strength and integrity of the fire gutted NASACO Building, a well qualified, equipped and experienced CONTRACTOR need to be commissioned to carry-out the job under close supervision of a reputable structural

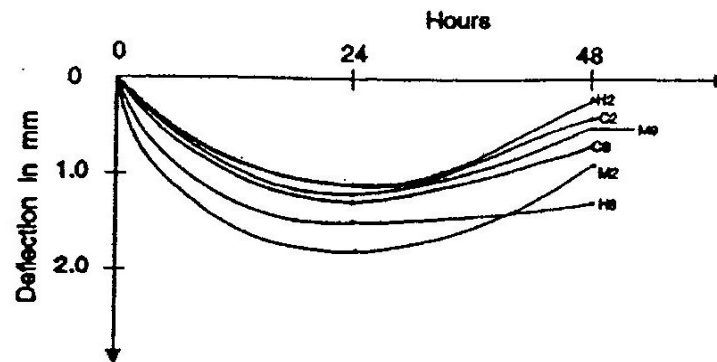
**Fig. 6 Appropriate deflection pattern**

For appropriate deflection pattern, the structural member deflects from zero to a certain value while under-load, then after off-loading, it goes through a recovery process. This pattern is shown in Figure 6 where by the deflection of the selected central points has been presented.
